**SITE ASSESSMENT REPORT**

**Hi-Tech Plating Facility A.K.A.  
Abandoned Electroplating Facility  
Balch Springs, Dallas County, Texas**

**Ecology and Environment, Inc.  
Technical Assistance Team**

**30 June 1990**

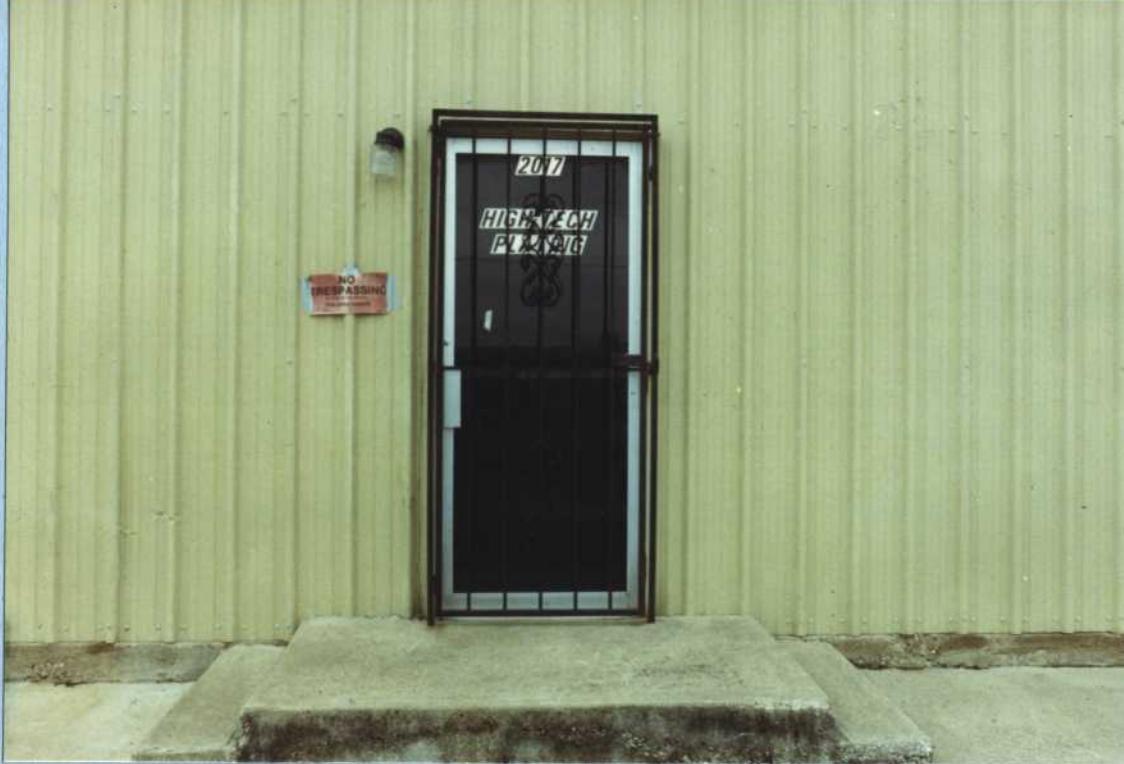
**1**

**Comments:** Front entrance to building with "No Tresspassing" signs erected by Fire Dept.

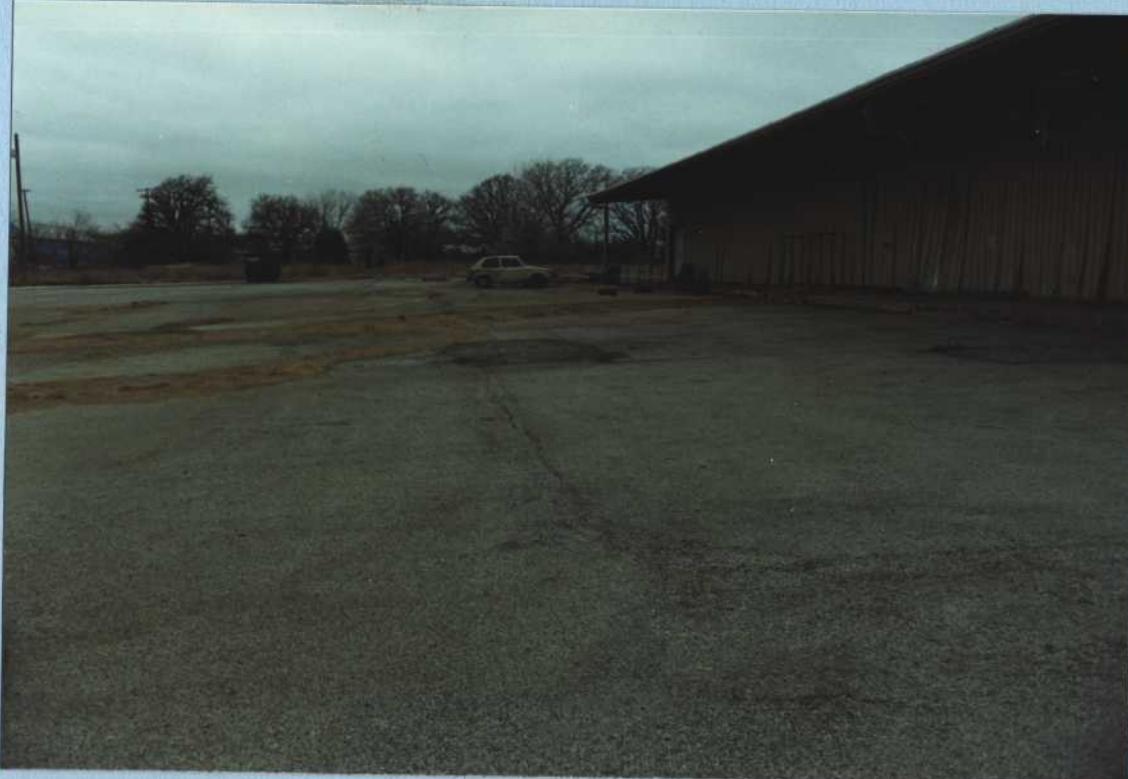
**2**

**Comments:** Sanded portion of parking lot where leak occurred.

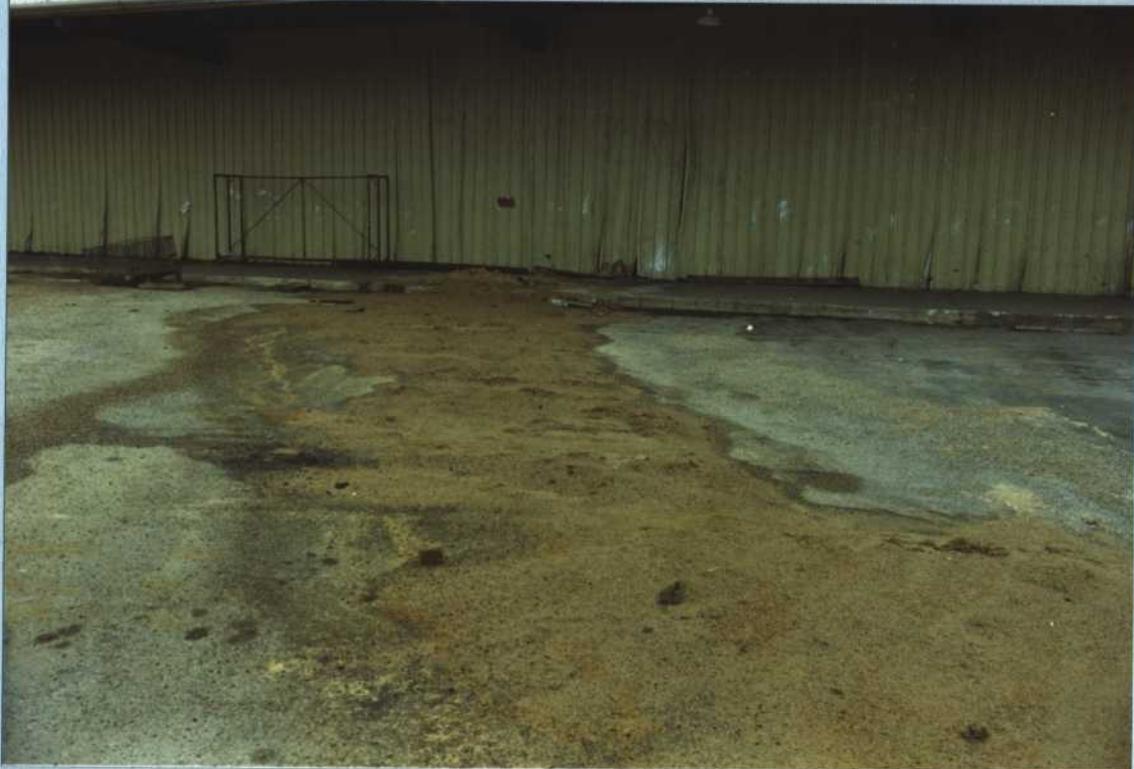
**3**

**Comments:** Sanded area near south wall where leak occurred.

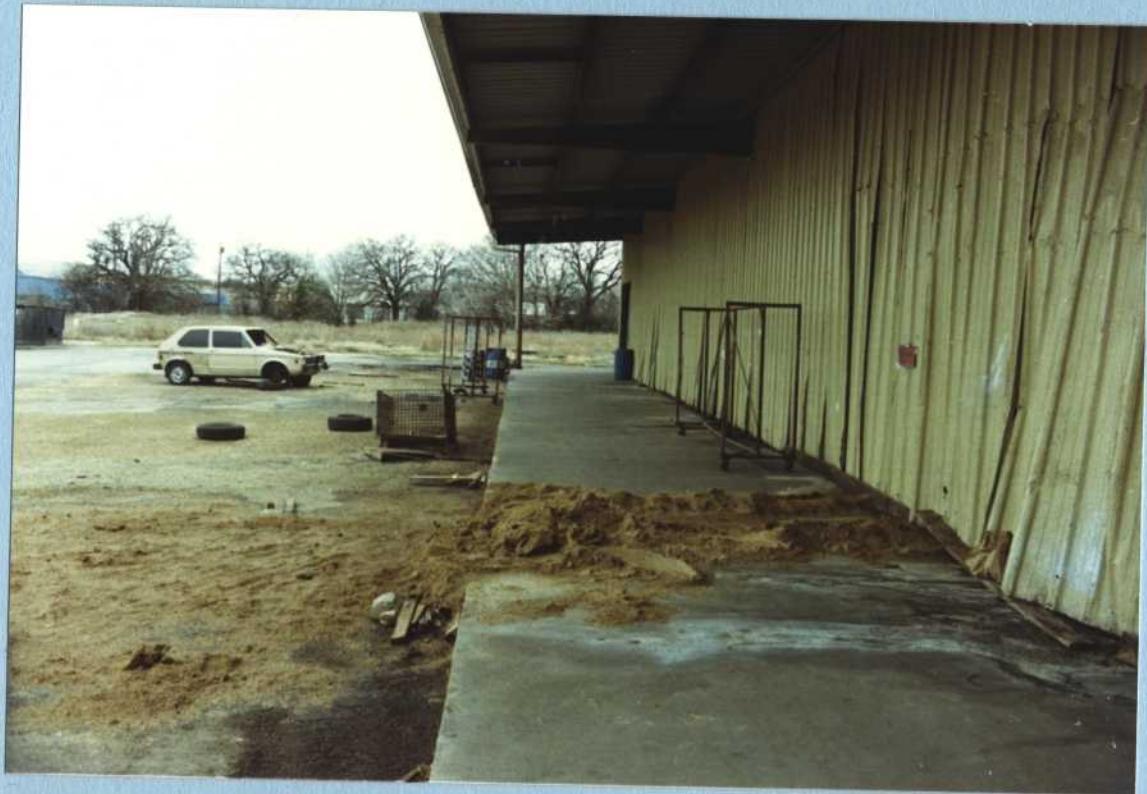
**4**

**Comments:** South wall corroded by leaking vats.

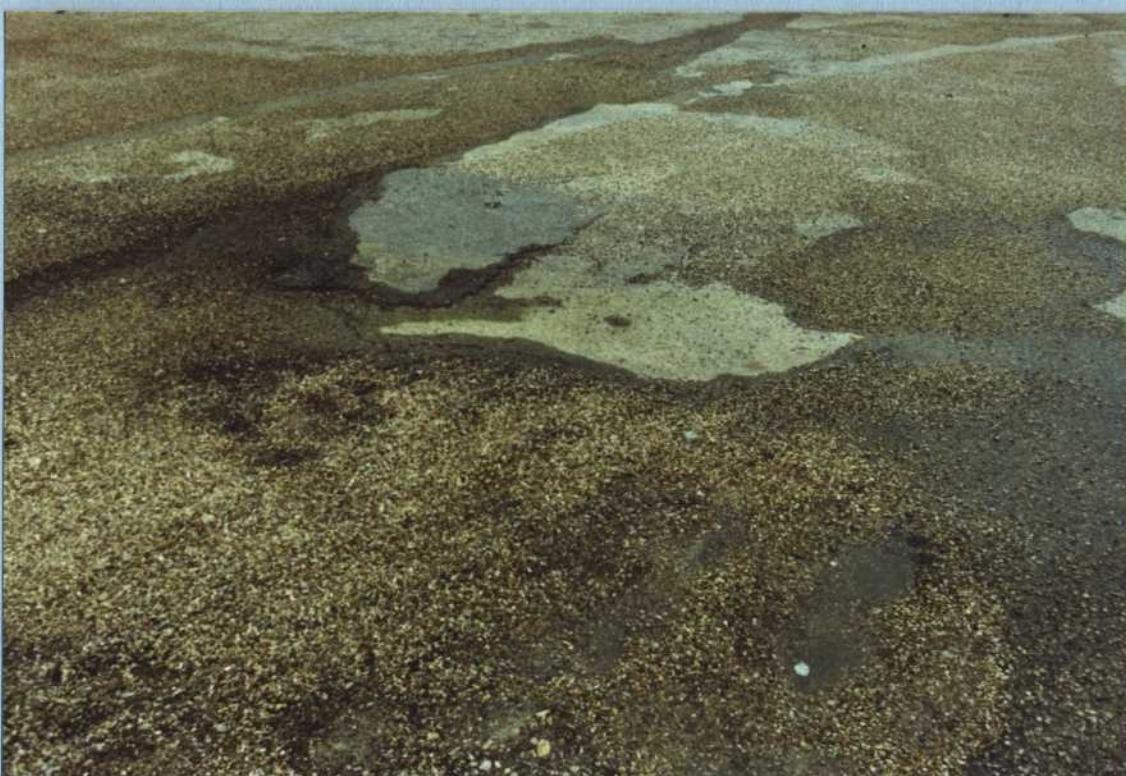
**5**

**Comments:** Green discoloration in area where leak occurred.

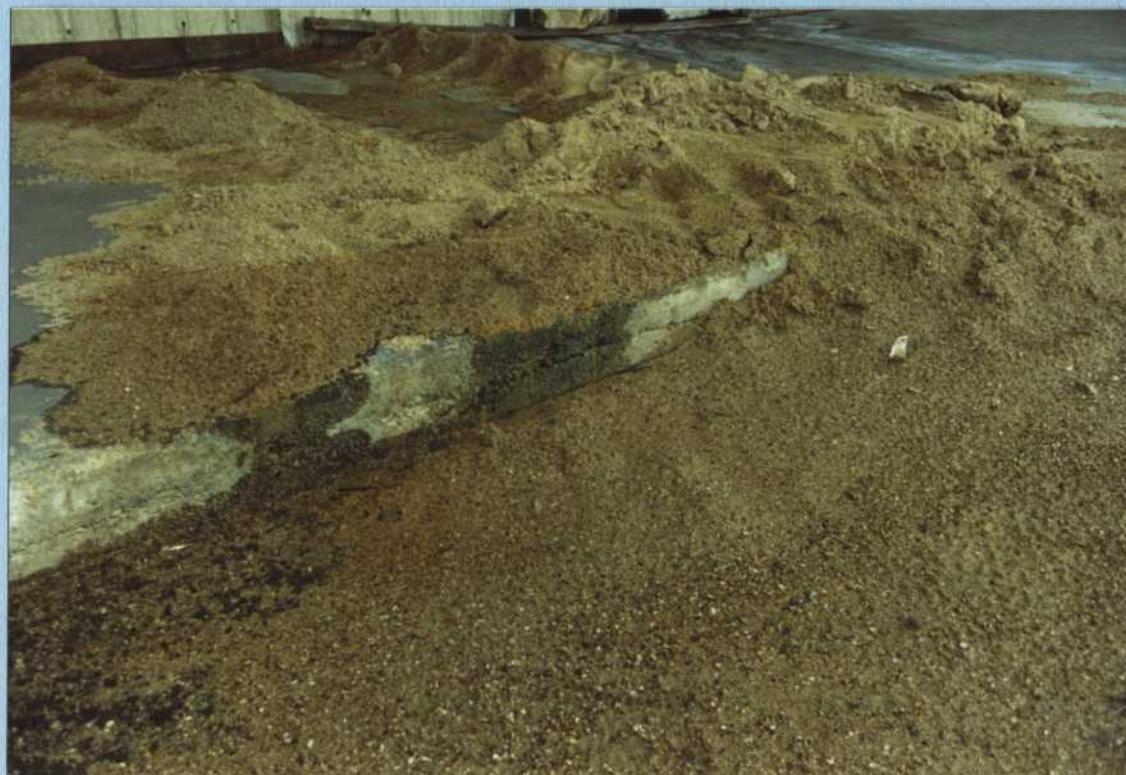
**6**

**Comments:** Corrosion in concrete caused by leaking material.

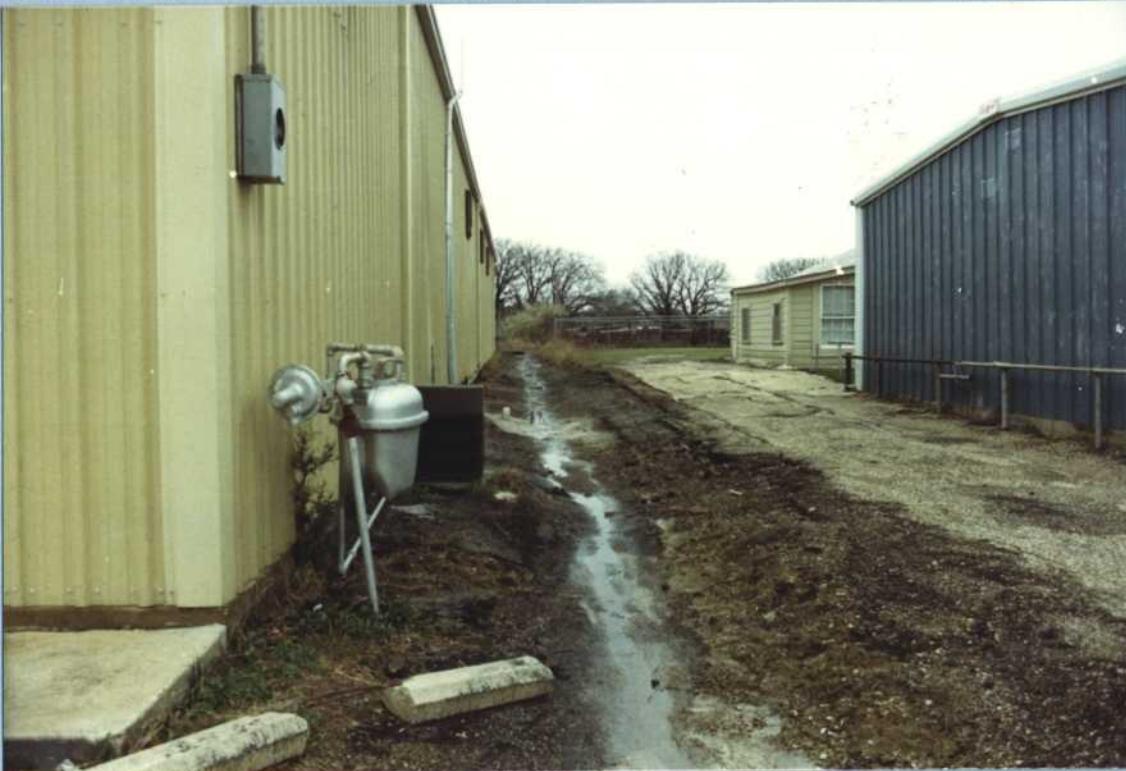
7

**Comments:** Drainage area along north side of building, pH of standing liquid was neutral (6-7).

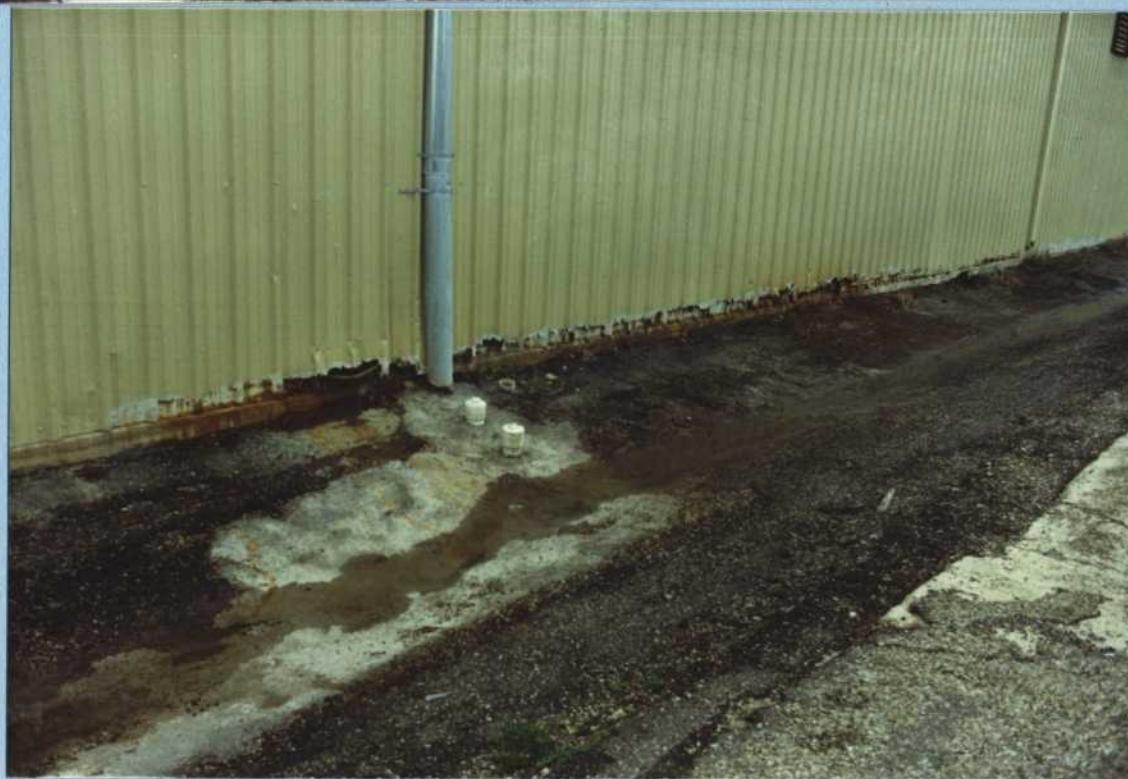
8

The site is readily accessible from nearby Peachtree Road and is surrounded by occupied buildings and businesses located within 25 feet of the facility . Upon arrival at the site on 28 February 1990 at 1430 hours , TAT observed sanded material near the south wall of the site and along a pathway through the site parking lot to a drainage ditch on the southeast corner of the site (Photos # 2 & 3). Dead vegetation was observed in the drainage area where the flow entered the drainage ditch. TAT also observed a green discoloration near the sanded material, and part of the concrete foundation near the sanded portion of the building was corroded (Photos # 5 & 6). The bottom of the north wall also had openings which appeared to be caused by the leaking material (Photo # 8).

**Comments:** Openings in north building wall caused by corrosive materials.

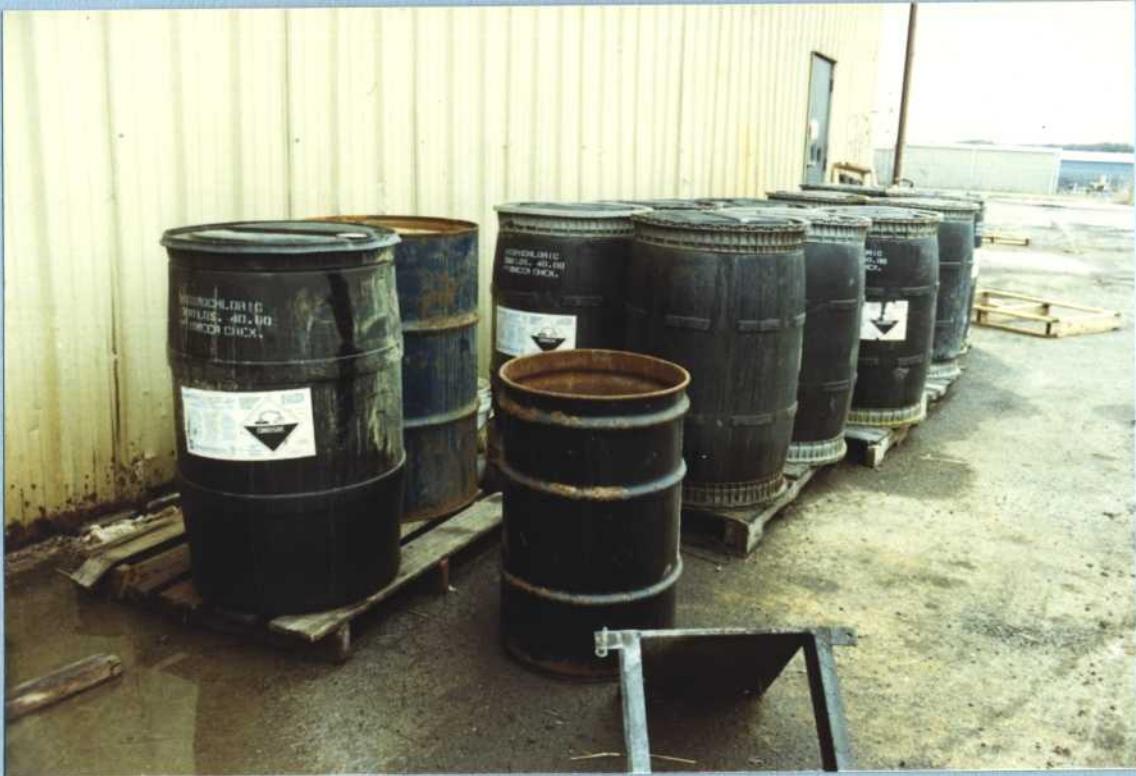
**9**

Approximately 15 fifty-five gallon drums labeled as containing hydrochloric acid and aluminum etch were located outside the north wall of the building (Photos # 9 & 10) . A majority of the drums seemed to contain large amounts of products or wastes and were unopened.

**Comments:** Drums of HCl located on west end of site.

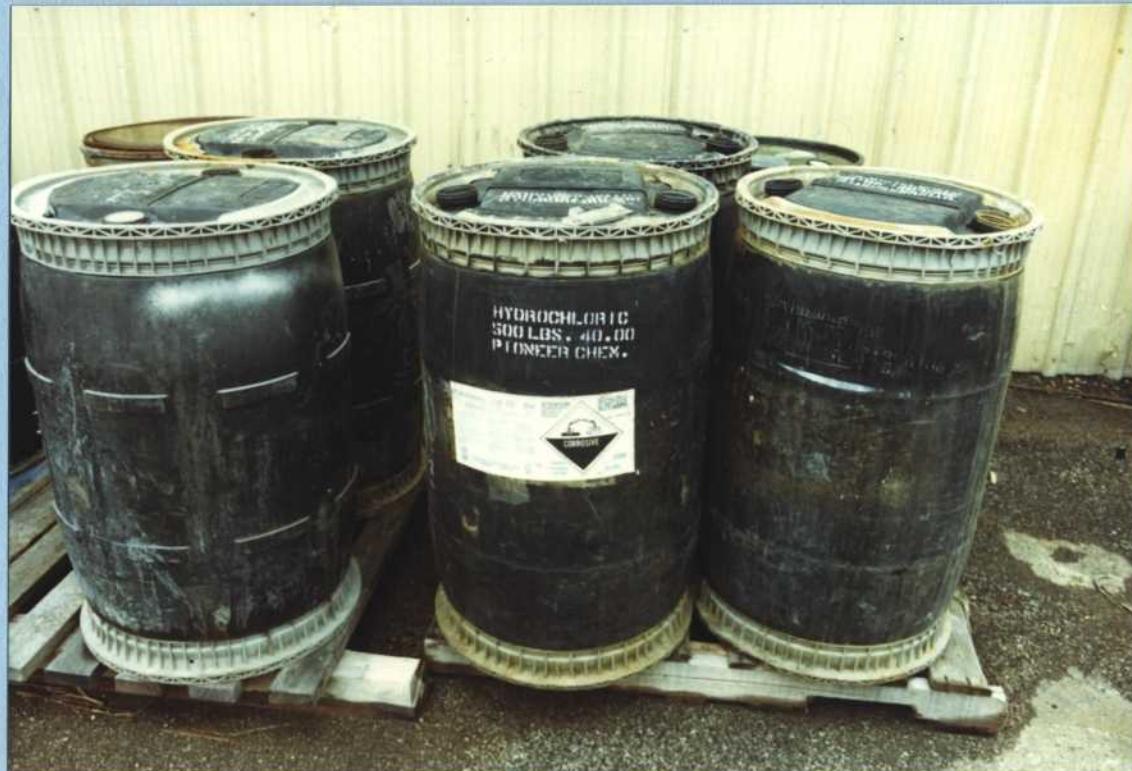
**10**

**Comments:** Labeling on containers located outside of building.
